Property Inspection Report

**123 Sample Report Drive
Atlanta, Georgia 30303**

Inspection Date:
October 21, 2007

Prepared By:
Inspector: William Ahitgrad
AAA Home Inspection Services, Inc.
Atlanta, Georgia

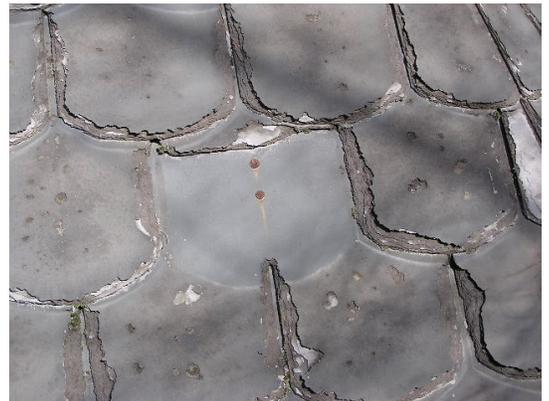
- **Repair:** The slate roofing is poor condition, and may be near the end of its useful life. Conditions observed include damaged and missing tiles, surface deterioration, and exposed nail heads. No active leaks were observed at the time of inspection. The slate roof should be evaluated by a qualified contractor, and repaired/replaced as needed. See photo on page 8.

- **Repair:** The slate roofing is poor condition, and may be near the end of its useful life. Conditions observed include damaged and missing tiles, surface deterioration, and exposed nail heads. No active leaks were observed at the time of inspection. The slate roof should be evaluated by a qualified contractor, and repaired/replaced as needed. See photo on page 7.

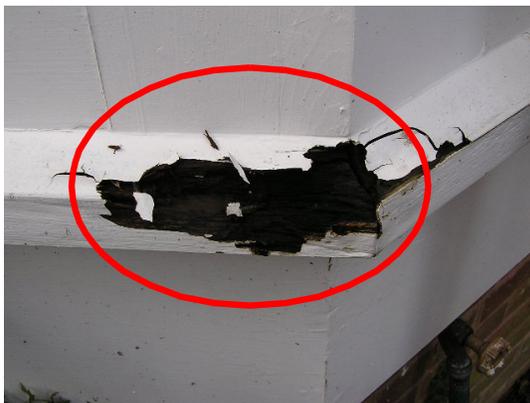
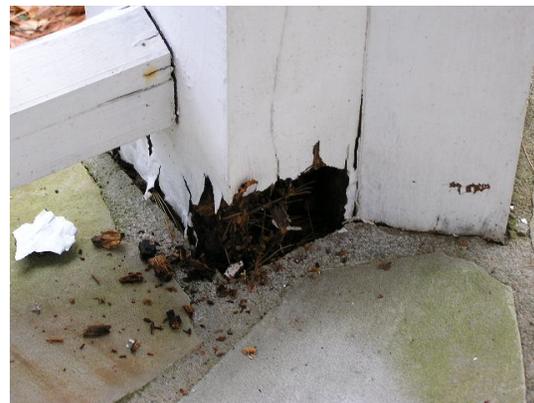
- **Repair:** Wood rot and deterioration was observed in multiple areas of the exterior, and should be repaired as needed by a qualified contractor. Locations include, but are not limited to, the exterior siding and trim, windows, porches including decking and railings, the bases of the support columns for the gazebo, and rafter tails on the right rear corner of garage. See photos on page 9.

- **Repair:** Substantial wood rot and deterioration was observed in multiple areas of the exterior, and should be repaired as needed by a qualified contractor. Locations include, but are not limited to, the exterior siding and trim, windows, porches including decking and railings, the bases of the support columns for the gazebo, and rafter tails on the right rear corner of garage. See photos on page 8.

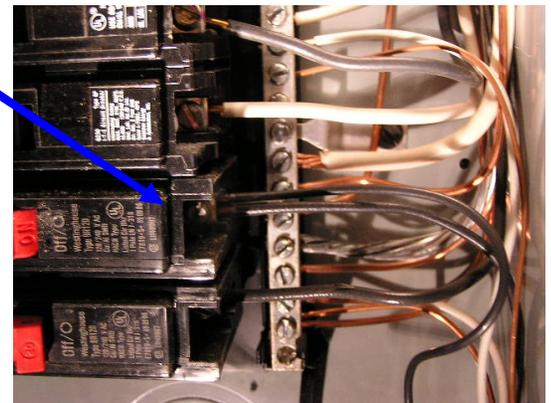
- **Repair:** Circuits within the electric panel that are doubled up (referred to as "double taps") on a 20 amp breaker, should be separated. Each circuit should be served by a separate breaker.

- **Repair:** Circuits within the electrical panel that are doubled up (referred to as “double taps”) on a 20 amp breaker, should be separated. Each circuit should be served by a separate breaker. See photo on page 9.

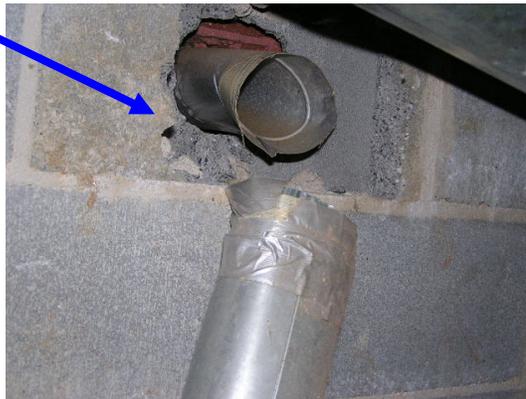
- **Repair:** The left front burner on the gas cooktop would not ignite, and should be adjusted or repaired.
- **Repair:** The metal flue pipe for the cooktop downdraft exhaust fan is disconnected in the crawl space, and should be properly reconnected to discharge to the exterior.

- **Repair:** The left front burner on the gas cooktop would not ignite, and should be adjusted or repaired.
- **Repair:** The metal flue pipe for the cooktop downdraft exhaust fan is disconnected in the crawl space, and should be properly reconnected to discharge to the exterior. See photo on page 14.
